INFRARED THERMOGRAPHY REPORT

General Products Co.

12/08/2025

Electrical System Reliability & Safety Solutions

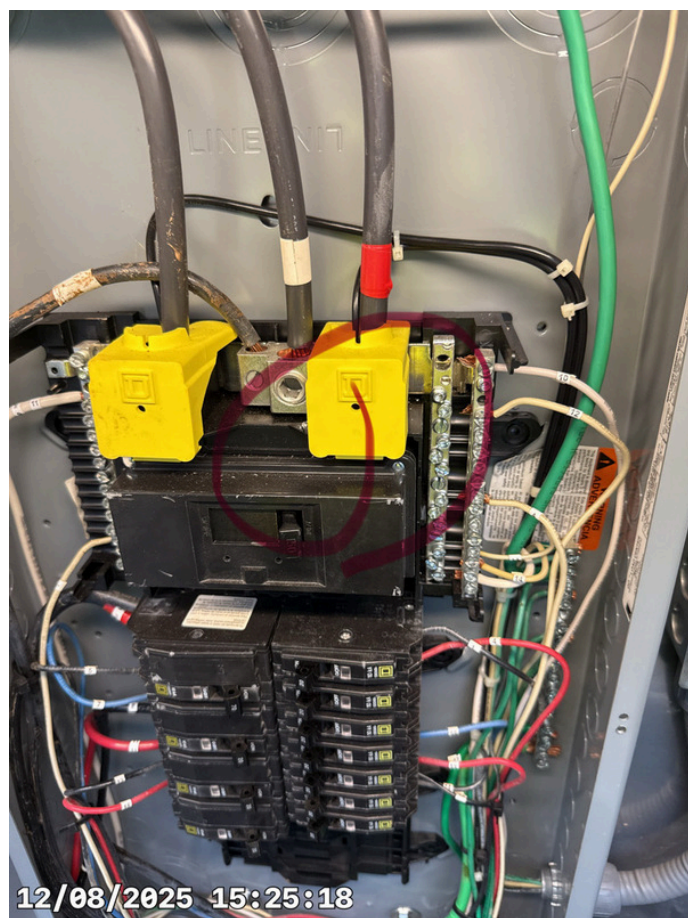
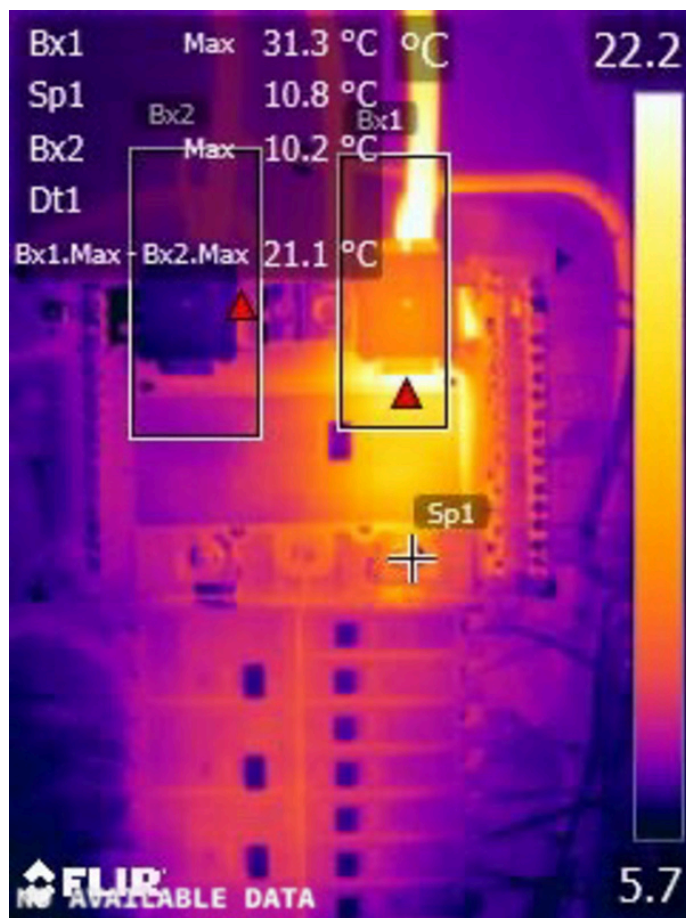
Infrared Inspection Records - 48. Main Power Distribution Room

Equipment Location	Main Power Distribution Room
Equipment Type	Distribution Panel
Primary Equipment Voltage	240 V
Reference Temperature (°C)	10.2 °C
Target Temperature (°C)	31.3 °C
Temperature Differential (°C)	21.1 °C
Thermal Condition Level	Critical >15.1 °C
Electrical Anomalies & Recommendations	5. Wire Terminations and Crimps - Recommendation: Inspect and re-terminate as necessary, following NEC standards. Use dielectric grease to maintain secure connections.
Notes (as needed)

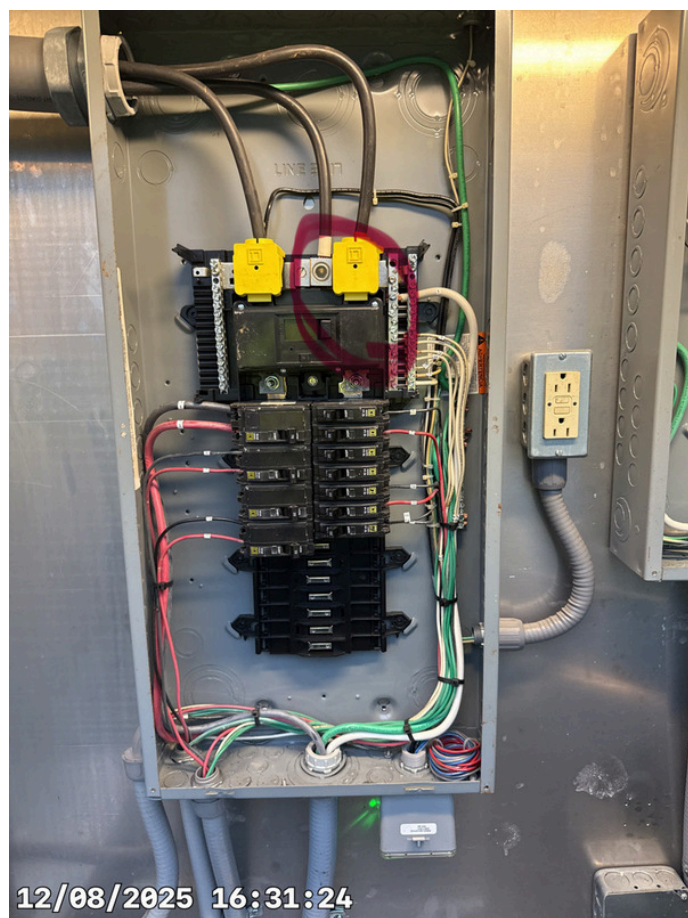
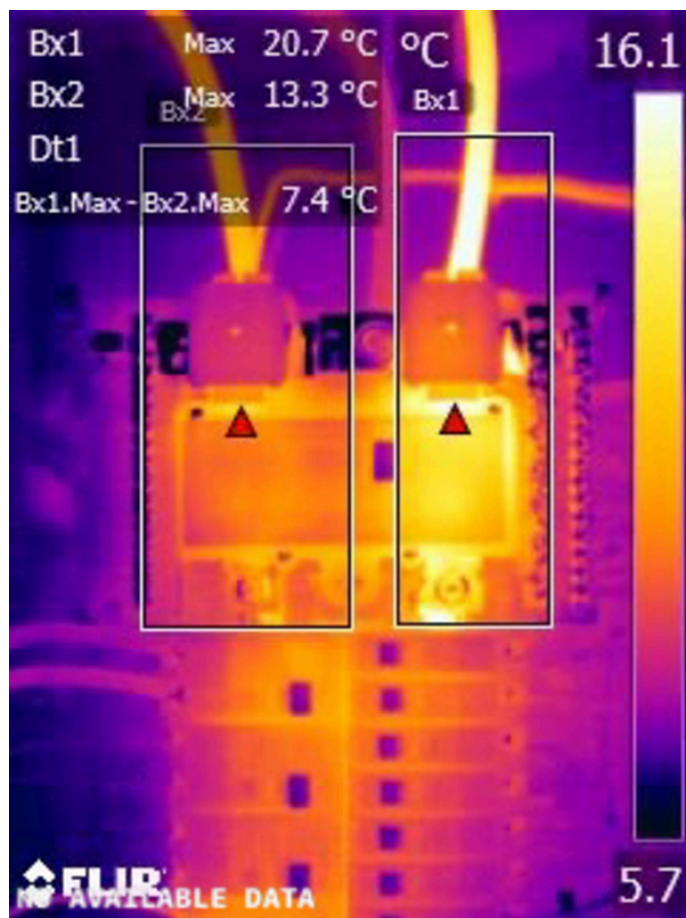
Infrared Inspection Records - 69. Main Power Distribution Room

Equipment Location	Main Power Distribution Room
Equipment Type	Distribution Panel
Primary Equipment Voltage	240 V
Reference Temperature (°C)	13.3 °C
Target Temperature (°C)	20.7 °C
Temperature Differential (°C)	7.4 °C
Thermal Condition Level	Alert 4.1-8 °C
Electrical Anomalies & Recommendations	5. Wire Terminations and Crimps - Recommendation: Inspect and re-terminate as necessary, following NEC standards. Use dielectric grease to maintain secure connections.
Notes (as needed)
